Investigating the Effects of Corrosion on the Fatigue Life of Steel. (August 1997)

Todd S. Waldvogel, B.S., United States Air Force Academy

**INVESTIGATING THE EFFECTS OF CORROSION ON THE FATIGUE LIFE
OF STEEL**

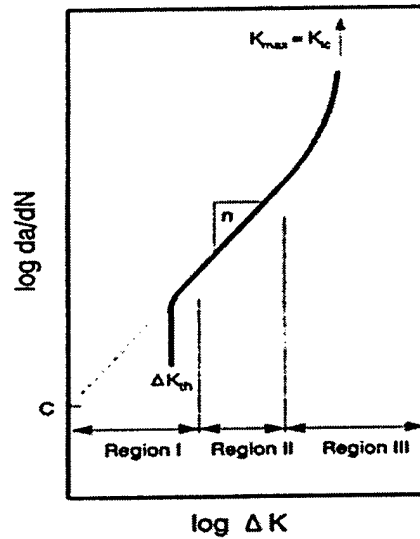
Figure 1. Fatigue crack growth vs. stress intensity factor range

This plot, which is independent of material strengths, reveals three distinct regions of different relationships. At lower values of crack propagation rate, there exists a threshold level, ΔK_{th} , below which the fatigue crack does not propagate. This behavior is represented as Region I. Beyond this threshold, crack propagation occurs at different rates. Within Region II the plot reveals a linear correlation between ΔK and da/dN . This demonstrates the Paris power law where the fatigue crack propagation behavior can be represented as:

where A and m are constants. Region III realizes an asymptotic increase of da/dN as K_{max} approaches the fracture toughness, K_{IC} .

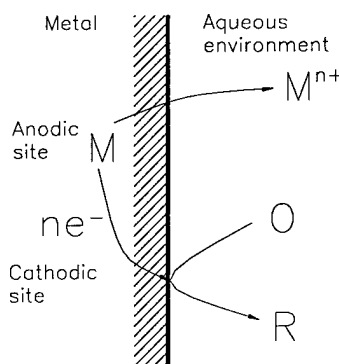
Figure 2. Schematic of corrosion process

Handbook, 1987). These two reactions take place on two distinct sites on the same surface as shown in Figure 2 (ASM Metals Handbook, 1987).

It the case of steel, the electrochemical reactions destroy exposed outer layers of steel. This destruction reduces the gross area of steel sections producing a negative affect from nearly all elastic design approaches. These design procedures force failure as a function of yield so as to promote significant plastic deformation upon failure to provide ample visual warning of collapse, “running time.” Accordingly, there is no wonder why the term “corrosion” conjures a negative connotation.

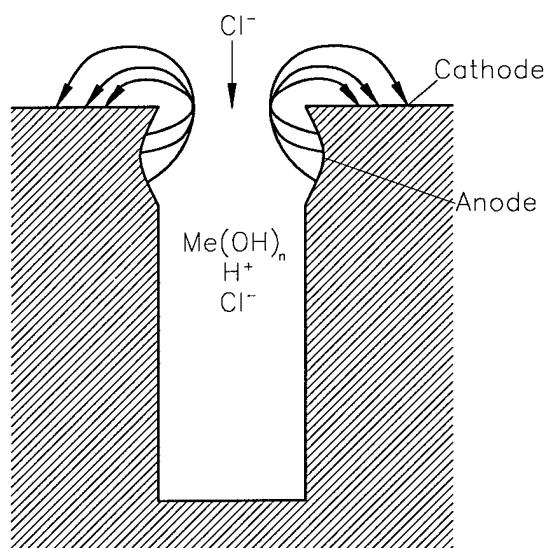
Figure 3. Crevice corrosion

Crevice corrosion will be a specific process expected in a specimen with a notched area. This type of corrosion can exist when the area of a small surface notch differs in environmental conditions. The geometry of a notch shields the immediate area from circulating fluid and allows for the stagnation of the immediate notch environment. Under such stationary conditions, the pH can decrease and the concentration of chloride can increase both resulting in higher corrosivity inside of the notch than outside. Anodic

The phenomenon of crevice corrosion helps explain the greater corrosion losses at the notch than at the specimen surface.

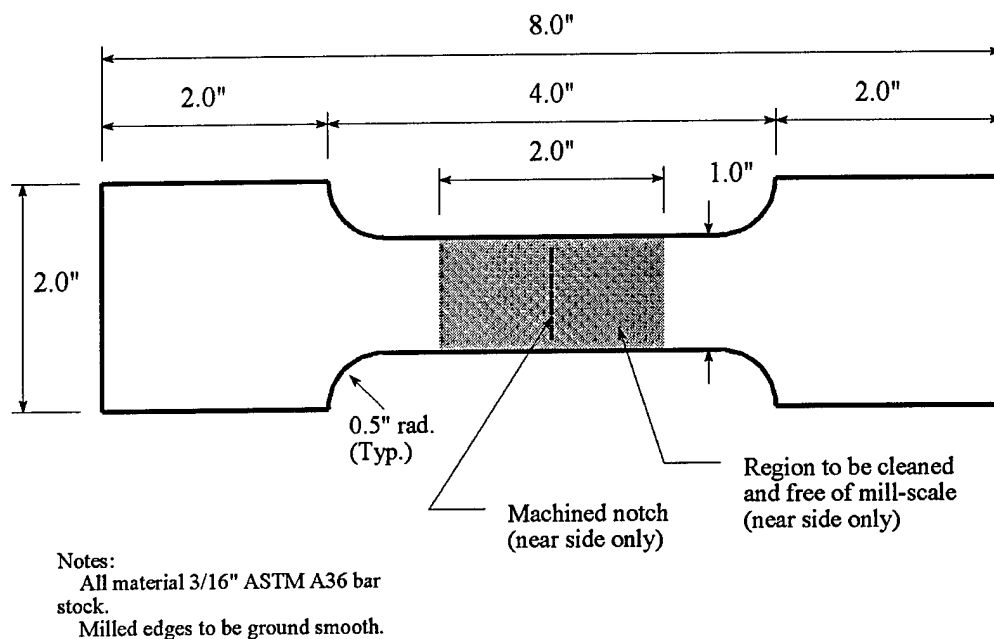
Figure 4. Specimen geometry

Steel tension specimens, fabricated from ASTM A36 3/16" X 2" bar stock, were used. The geometry of all specimens tested were identical to that presented in Figure 4. The notch in the center of the specimen was used to induce a stress concentration with a reproducible fatigue strength. This notch was machined to a depth of 1/32nd of an inch with a groove angle of 40 degrees. The area around the notch was sandblasted to remove the mill scale and isolate the corrosion process to a confined area.

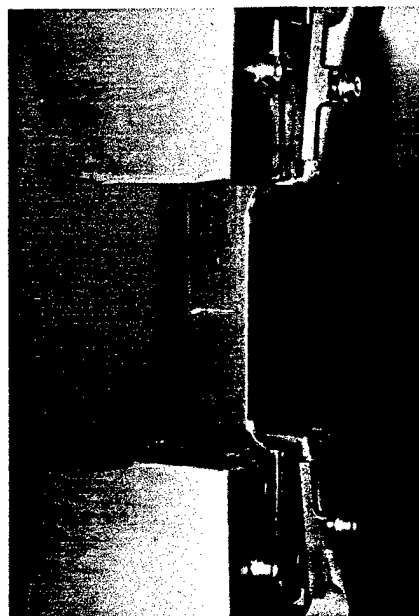
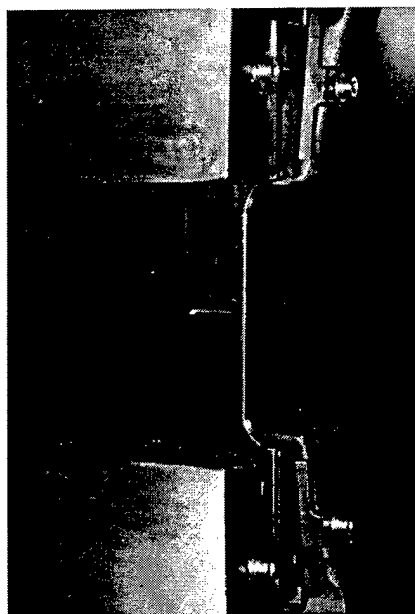
Figure 5. Specimen in tension

Three specimens, one from each 20 foot length of bar stock, were tested in tension (see Figure 5) to determine the yield and ultimate strengths of the steel. The plotted stress-strain results of these tests are presented as Figure 6. As indicated by the stress-strain plots in Figure 6, specimens B & C showed similar stress-strain behavior. It was assumed that similar stress-strain behavior is indicative of similar chemical characteristics. The bar stock for these two specimens were used to fabricate all of the corrosion specimens used in the test program. The specimens exhibited yield strengths of

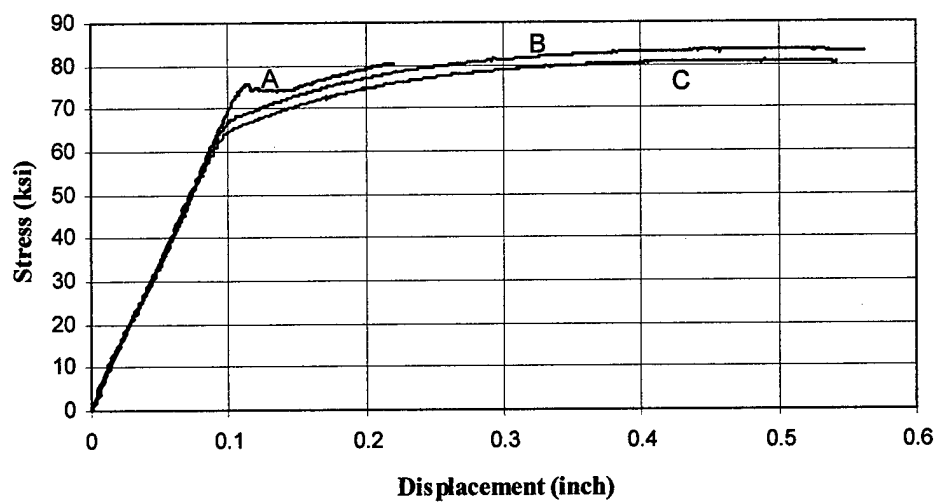
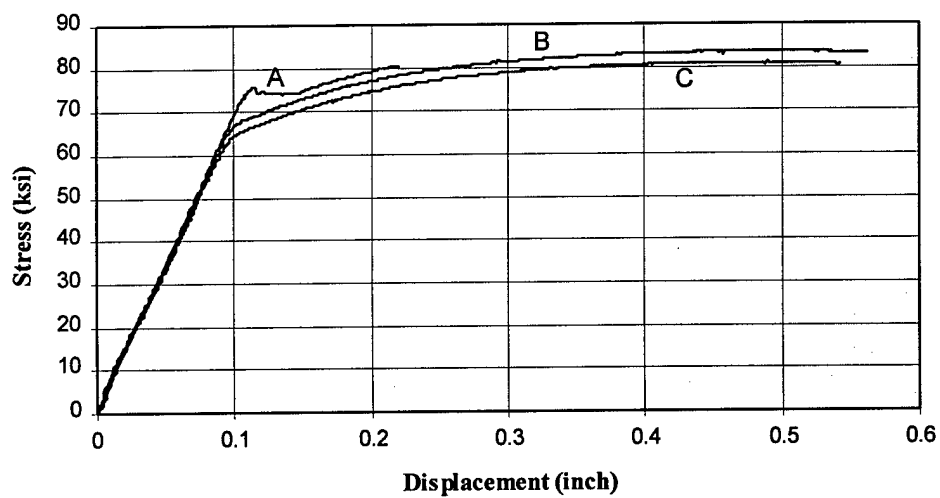
Figure 6. Yield test results

approximately 60 ksi, much higher yield than their 36ksi designation, and an ultimate strength of over 80 ksi.

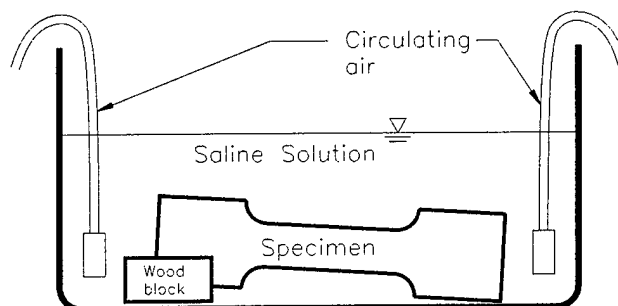
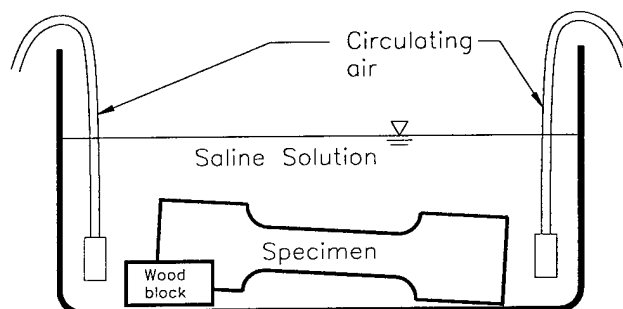
Figure 7. Set-up of corrosive environment

Twenty-four specimens comprised the test groups. These specimens were subjected to accelerated corrosion in a salt water bath. For each of two specimen groups, two gallons of distilled water were converted to a 3.5% salt solution by weight through the addition of 0.58 pounds of sodium chloride (NaCl), an environment similar to clean seawater (Mattsson 1989). This solution was thoroughly mixed and continually aerated and agitated with the assistance of a small aquarium air pump. The diagram in Figure 7 and the photograph in Figure 8 illustrate the set-up of the corrosive environment.

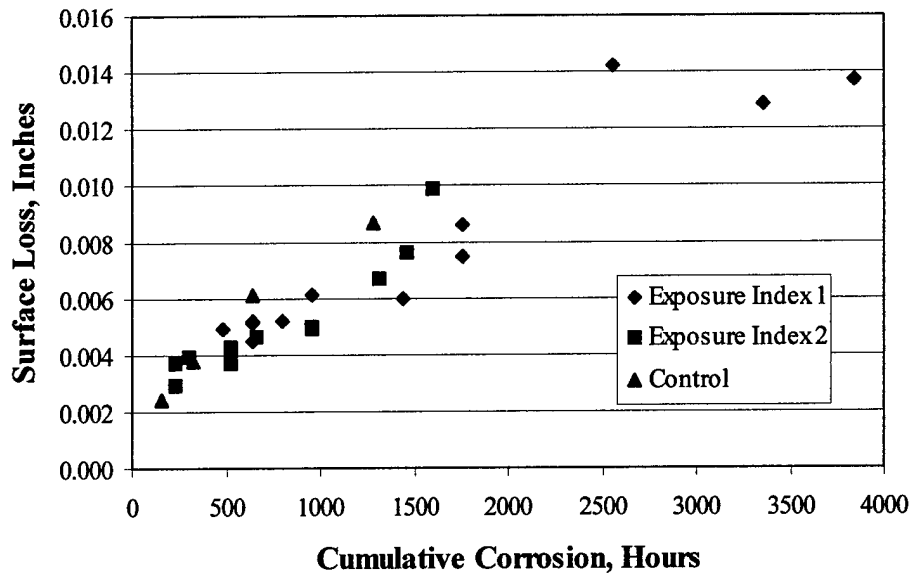
Figure 11. Corrosion rates

Figure 11 graphically presents the corrosion rates of the different exposure indices. As total corrosion exposure increases, there appears to be a decrease in the corrosion rates.

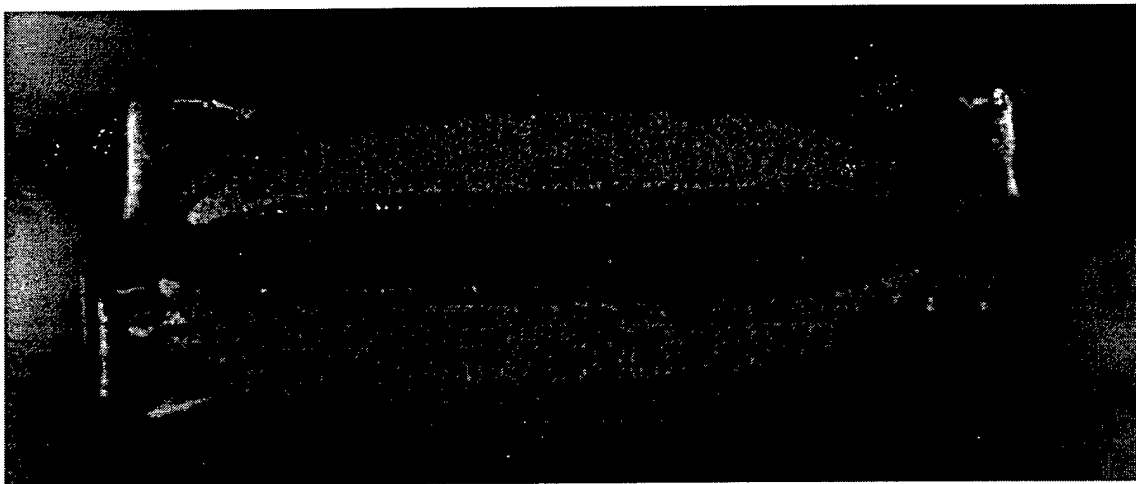
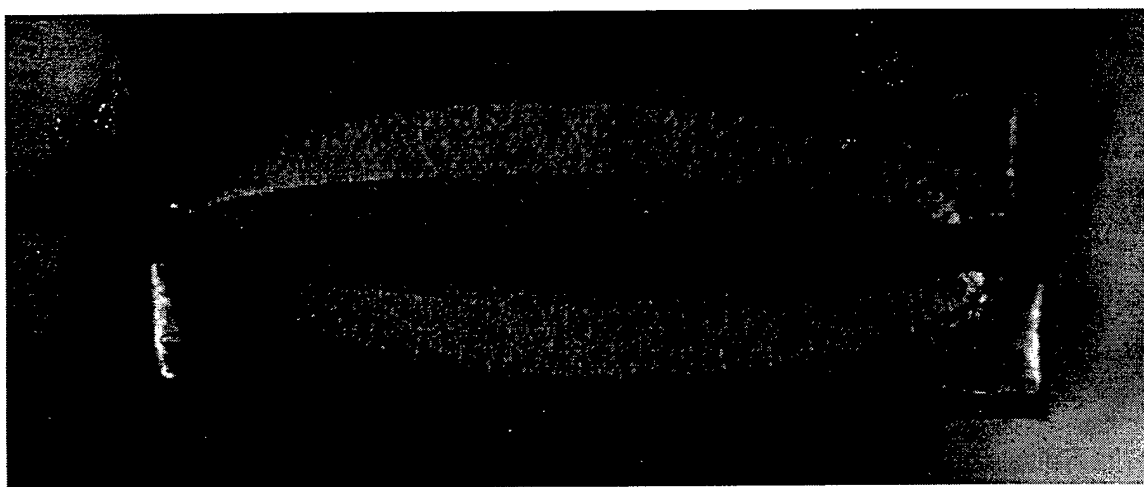
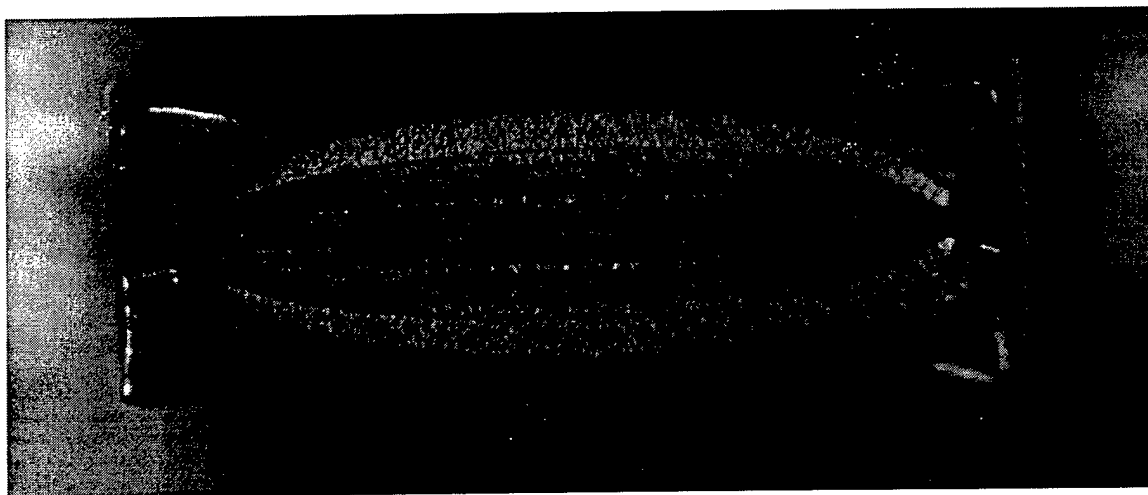
very similar times of exposure and thickness losses, but two experienced the greatest fatigue life while two experienced the shorted fatigue life. Photographs of the failed cross sections show the varying advance of corrosion over the total life of these specimens (Figures 12 - 15).

Figure 12. Failed cross section of specimen 1-1-2

Figure 13. Failed cross section of specimen 1-2-1

Figure 14. Failed cross section of specimen 2-3-1

further. Photographs of the failed cross sections in Figures 12-14 document the result of this process showing the stratification of levels of corrosion.

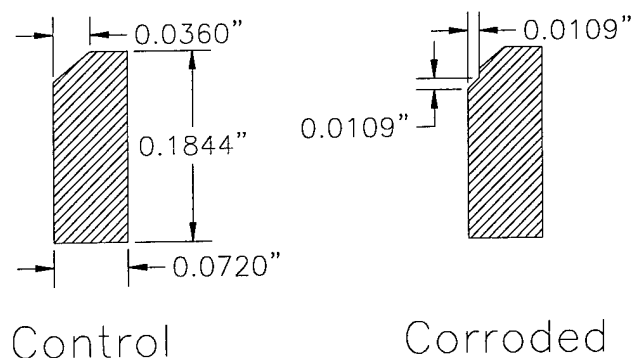
Figure 20. FEM geometries

The determination of stresses at the notch of this steel specimen can be accomplished using a finite element model and computer processing using ABAQUS and PATRAN. In order to do this, some simplifications and some approximations must be made to model the system. The geometry of the specimen as entered into ABAQUS and PATRAN is presented below as Figures 20 and 21. Using symmetry, only one half of the specimen must be analyzed from the centerline of the notch. The modeled specimen measured only 0.0720" from the centerline of the notch. At this point, it is safe to assume that the stress distribution returned to nearly uniform and is of not consequence when focusing on the notch. The modeled specimen height (0.1844") corresponds to the uncorroded thickness of Control Specimen 4 and is more accurate than the nominal 3/8" thickness. The thickness of the member into the page was taken as a "unit" thickness of 0.01" to represent any point of the specimen along the notch. Two geometries, each with 3150 elements, were considered representing the specimen before exposure to the corrosive environment and after 8 weeks of exposure. These elements were eight-noded quadratic elements. Only the corrosion at the notch was accounted for in the FEM computer model. The difference in surface thickness can be readily computed by hand and applied to the results.

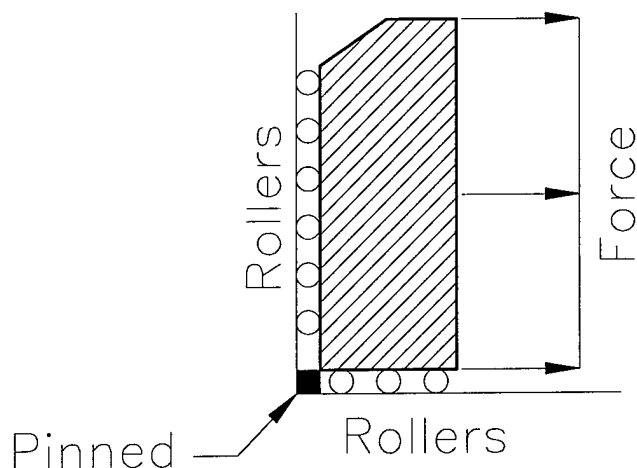
Figure 21. FEM boundary conditions

The member is modeled as having roller boundary restraints at the left edge—the interface of specimen symmetry. It is not allowed to deflect horizontally, but it is allowed to deflect vertically. This provides the specimen with the capability of necking due to the axial load. A pinned connection at the lower left corner maintains static equilibrium. Since the vertical “centroids” of the applied force and resistance are not equal, a moment is created. Unrestrained, the right end of the specimen model will deflect vertically from this resultant moment. If the entire specimen had been represented, equilibrium would have balanced these non-concentric forces. Since only one side is modeled, it is necessary to impose boundary conditions to simulate total equilibrium. This is accomplished by providing rollers to the bottom of the specimen to keep it from deflecting vertically (Figure 21). A 1000 pound/in distributed load was applied to the right side. This also provides for easy manipulation of the results.
